ADDENDUM TO
U.S. NAVAL BASE, PEARL HARBOR, TEMPORARY DRY
PROVISIONS STOREHOUSES
(U.S. Naval Base, Pearl Harbor, Naval Station)
(U. S. Naval Base, Pearl Harbor, Operational Storage Buildings
(Facility Nos. 146, 147, and 148)
Merry Point Wharf near North Road
Pearl Harbor
Honolulu County
Hawaii

HABS No. HI-414

U.S. NAVAL BASE, PEARL HARBOR, TEMPORARY DRY PROVISIONS STOREHOUSES
(Facility Nos. 146, 147, and 148)

Date of Report: October 2009

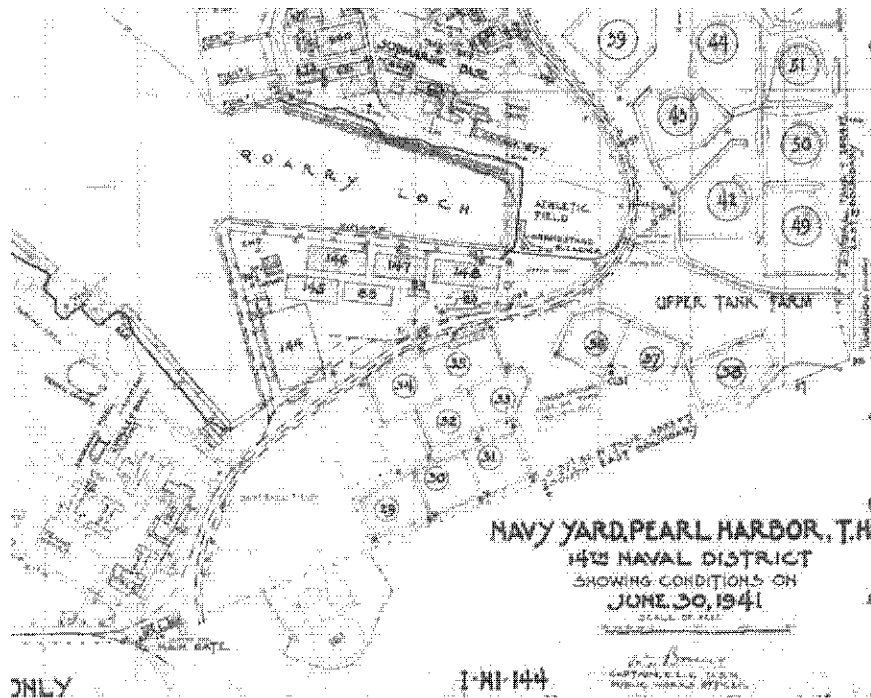
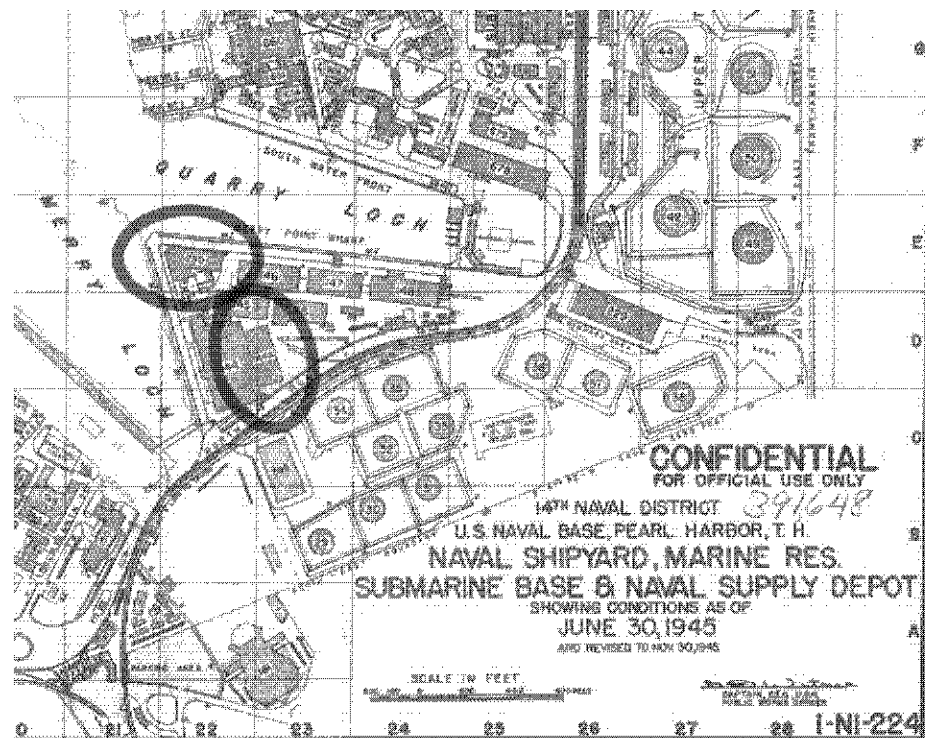
Portions of maps dated June 30, 1941 (top) and November 30, 1945 (bottom) showing the build out at Merry Point during WW II. Note that only two major buildings were built there during the war, they are highlighted on bottom map. (NAVFAC drwg I-N1-144 June 30, 1941 & I-N1-244 November 30, 1945).

The construction of these dry provisions storehouses and cold storage facility built out most of Merry Point's open space. As a result very little additional construction was done during World War II. In the course of the war, the only sizeable new structures to appear at Merry Point were Facility No. 230, a single-story, wood-frame transit shed, completed in 1942 (demolished 1985), and Facility No. 144A, an addition to the cold storage building, which was completed prior to the conclusion of the war in 1945.
